WATER TANK INSPECTION REPORT

Prepared for the

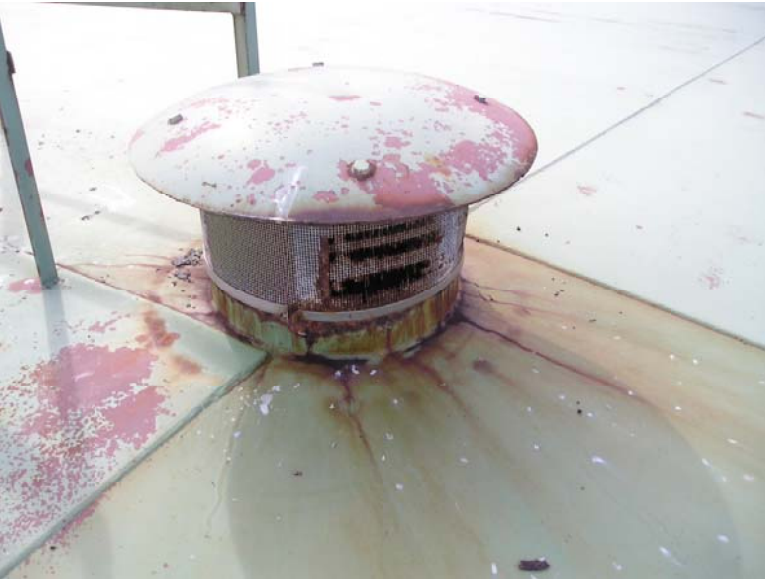
2MG
Steel
GROUND RESERVOIR #2

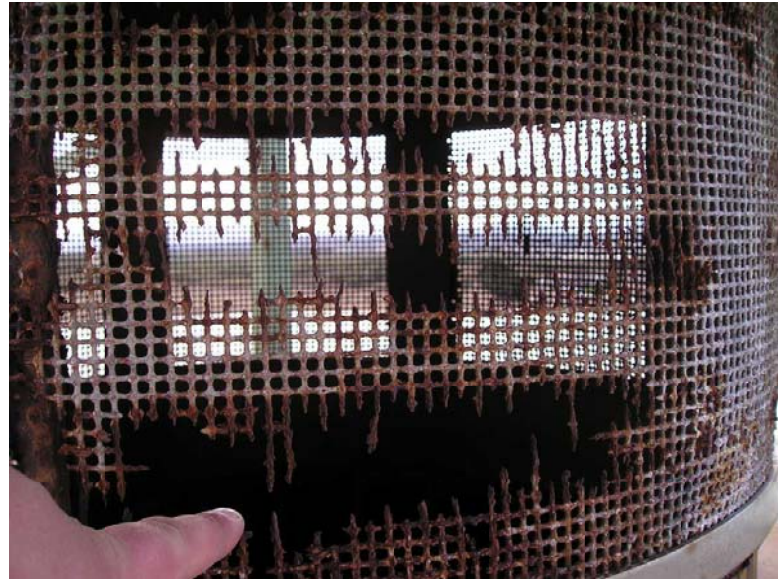
Roof vent screen badly corroded and crumbling.

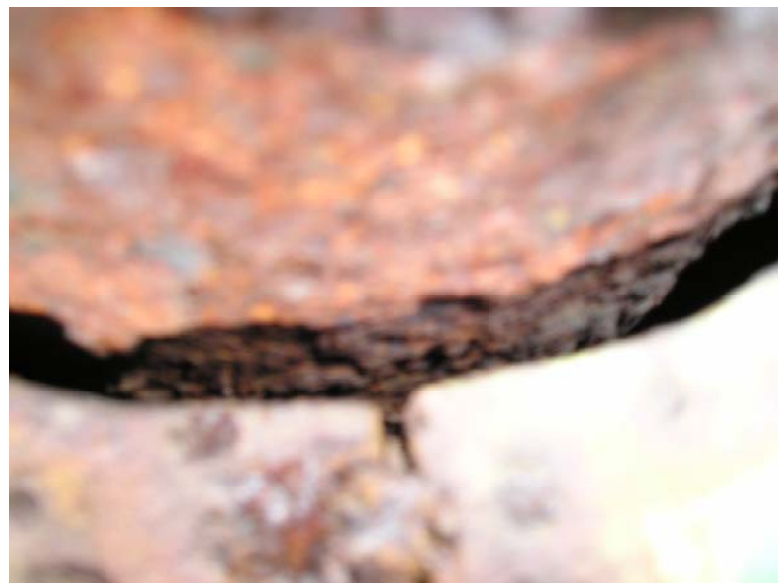
Inlet pipe coating failure and active corrosion

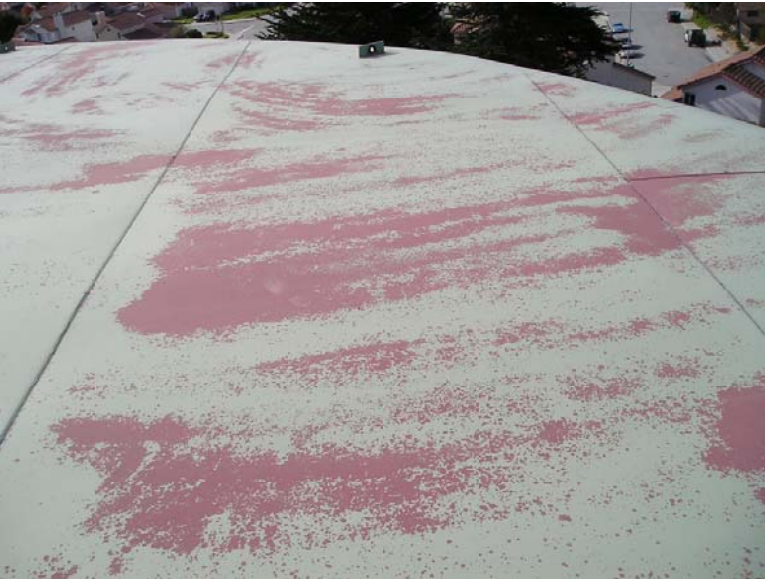
DP#05.JPG
Top coat failure on roof plate

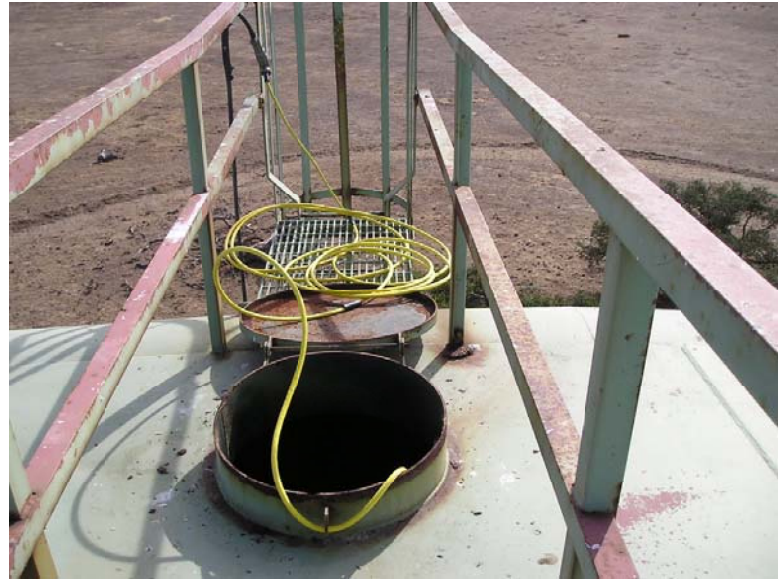
DP#06.JPG
Roof hatch with corrosion on edges

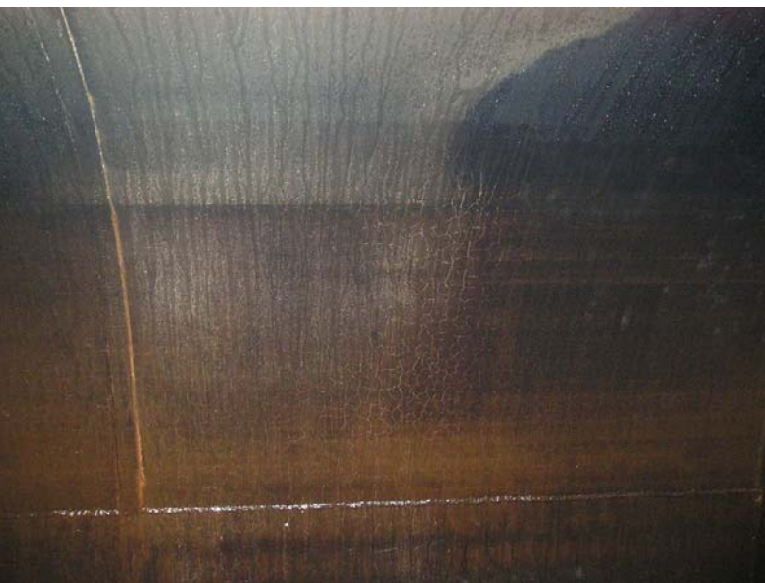
DP#07.JPG
Internal shell - cracks in coating

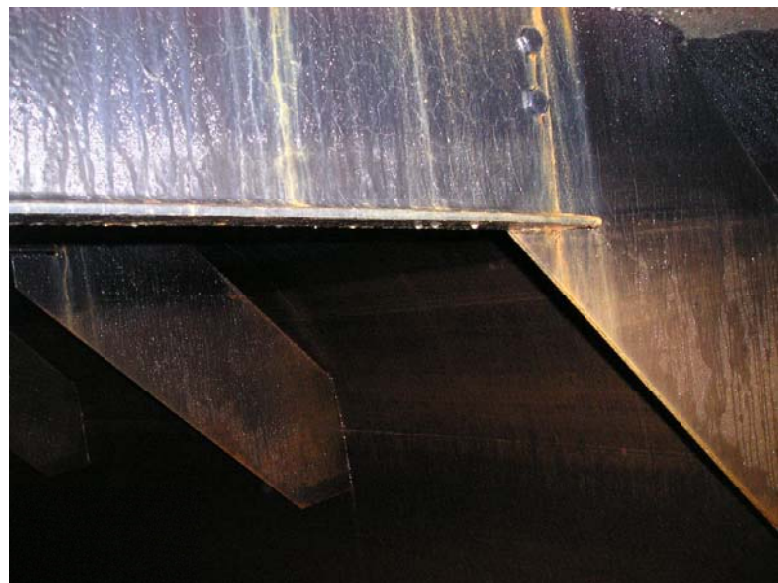
DP#08.JPG
Roof rafter with edge corrosion

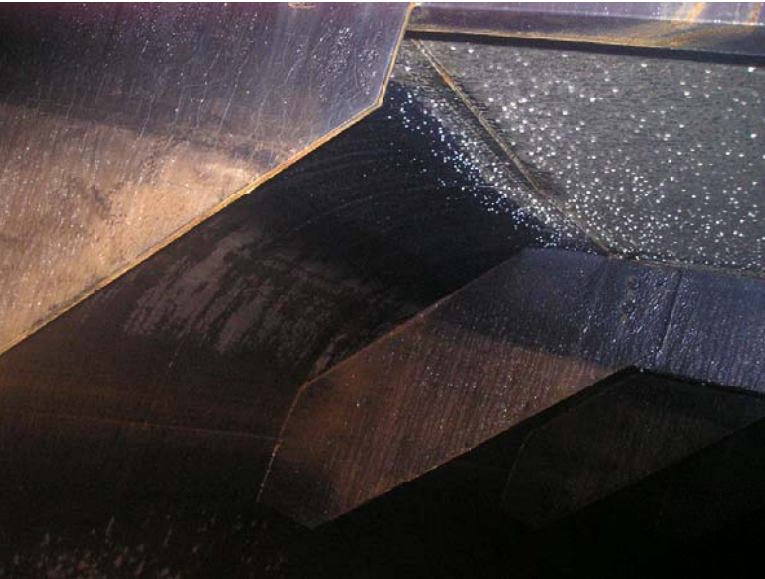
DP#09.JPG
Roof rafters with edge corrosion

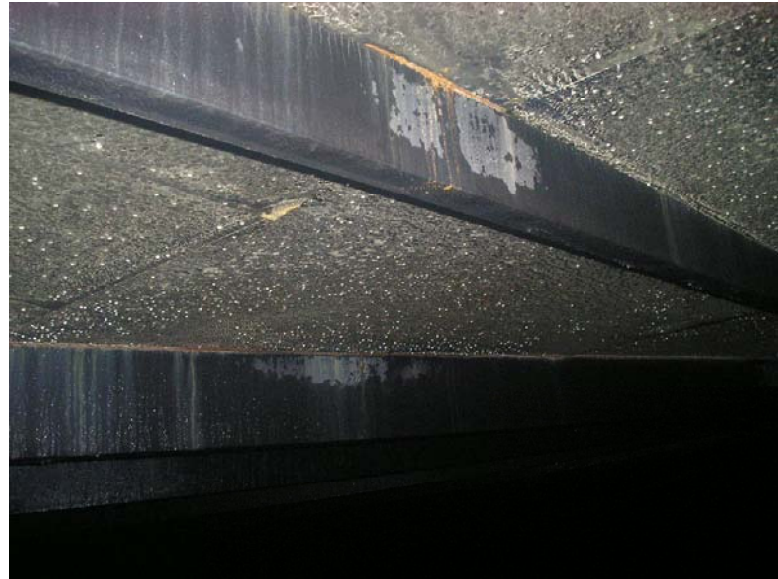
DP#10.JPG
Roof rafter with edge corrosion

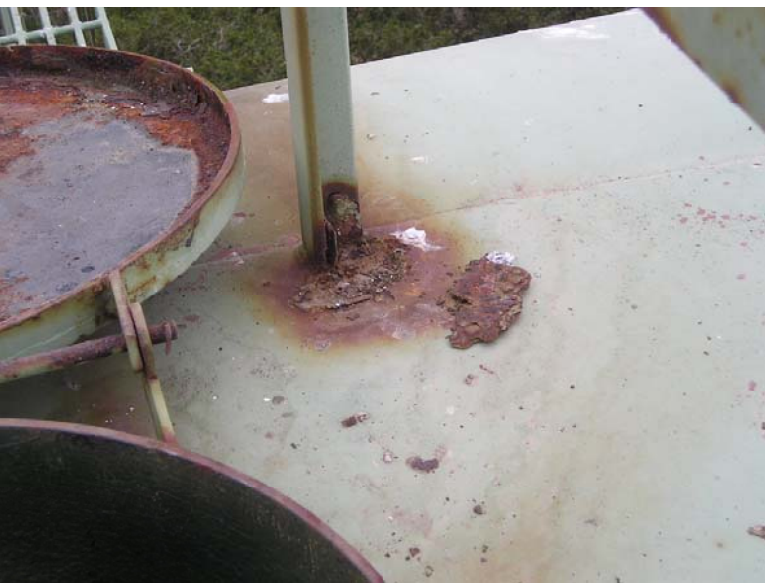
DP#11.JPG
Roof plate and hand rail active corrosion

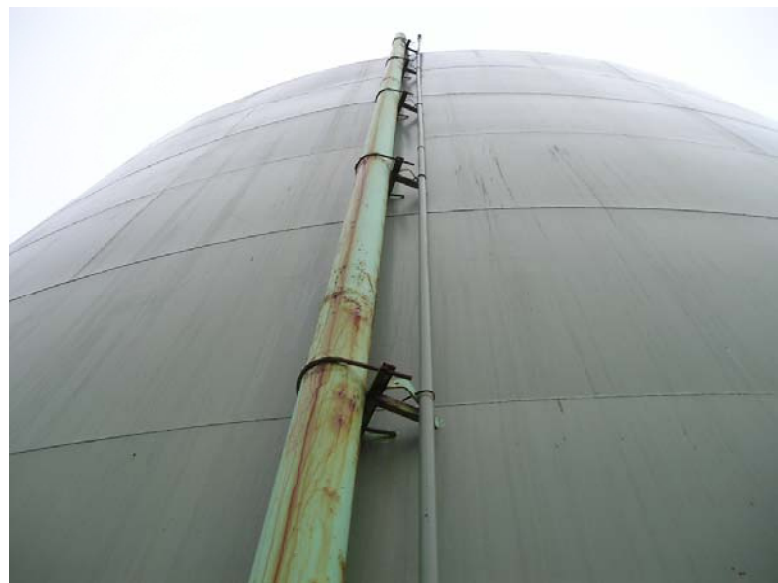
DP#12.JPG
Inlet pipe with active corrosion

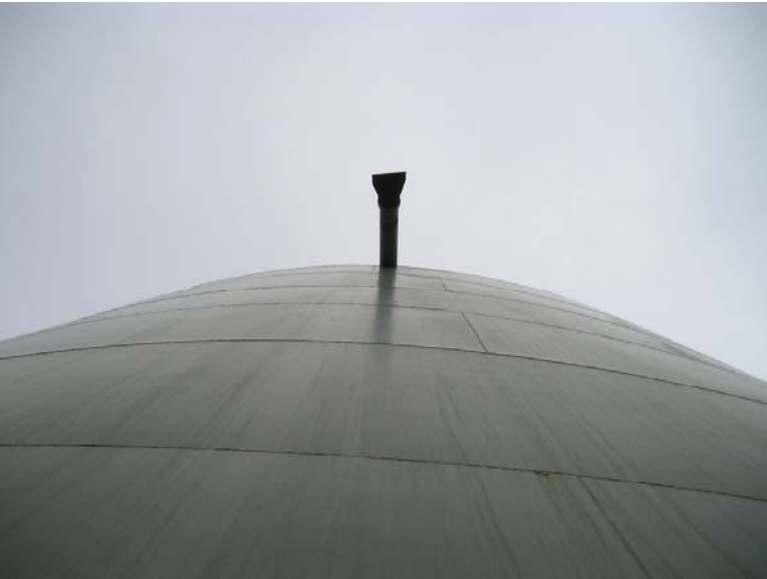
DP#13.JPG
Overflow pipe with flapper

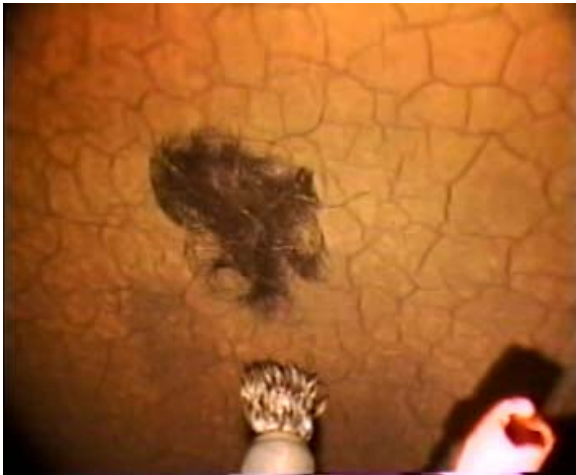
VS #1. Heavy iron buildup and cracks in coating. (Time: 2:09)

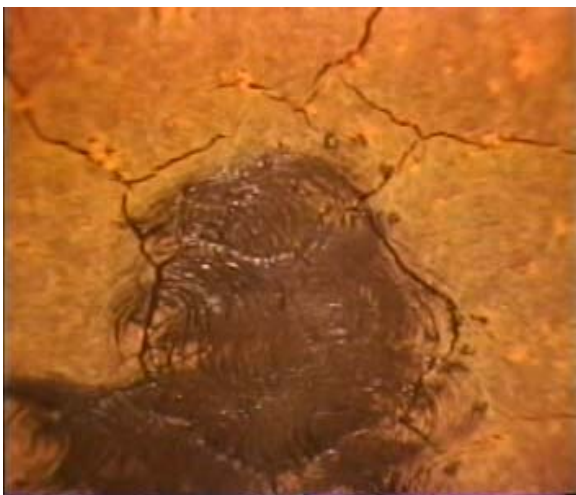
VS #2. Cracks in internal coating. (Time: 4:28)

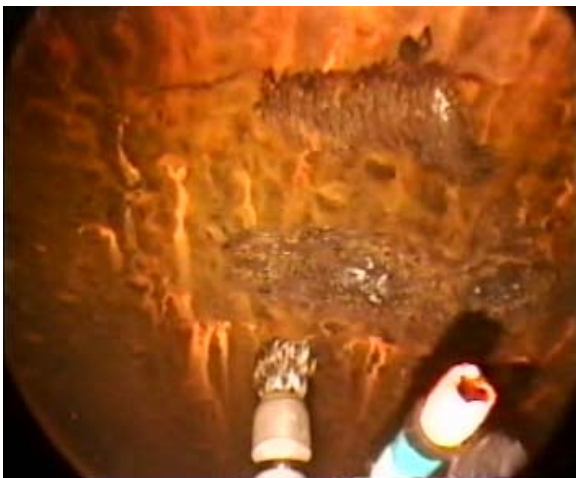
VS #3. Coating has failed, active corrosion, exposed steel upper shell at 8'oclock position. (Time: 6:57)

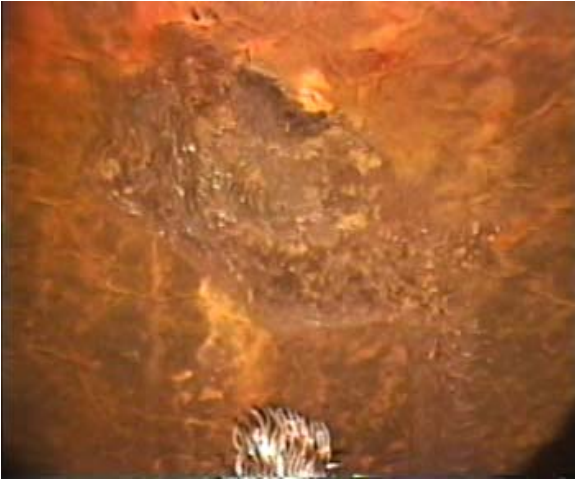
VS #4. Coating has failed to steel substrate 2nd shell 6'oclock position.
(Time: 10:20)

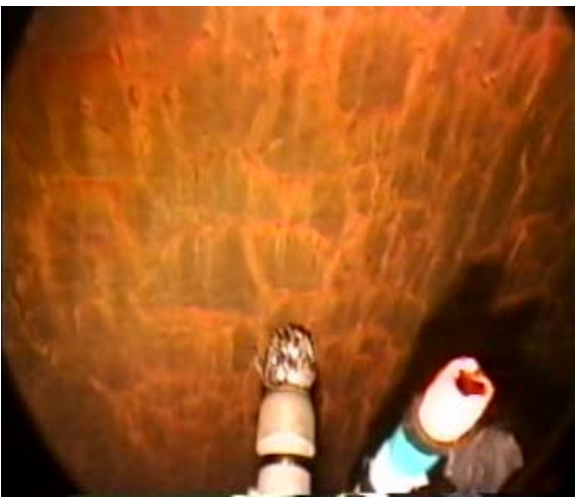
VS #5. Cracked coating and active corrosion. (Time: 10:46)

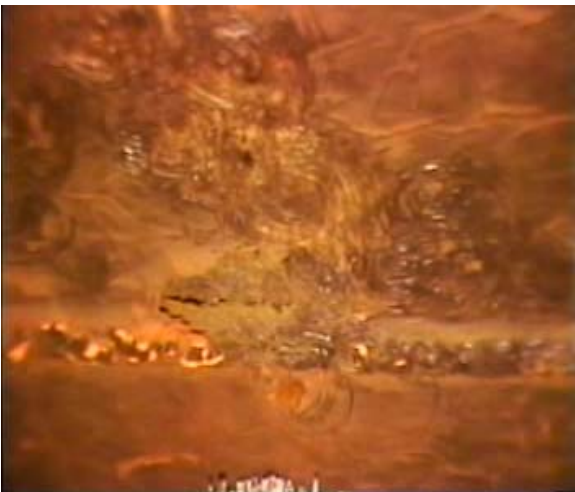
VS #6. Coating failure on horizontal weld. (Time: 15:47)

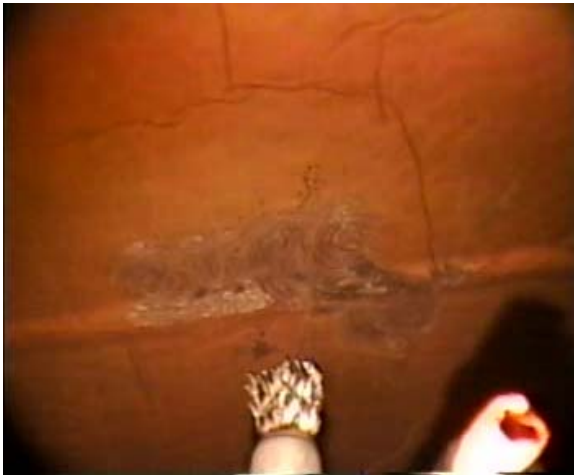
VS #7. Exposed steel substrate mid-shell corrosion. (Time: 21:35)

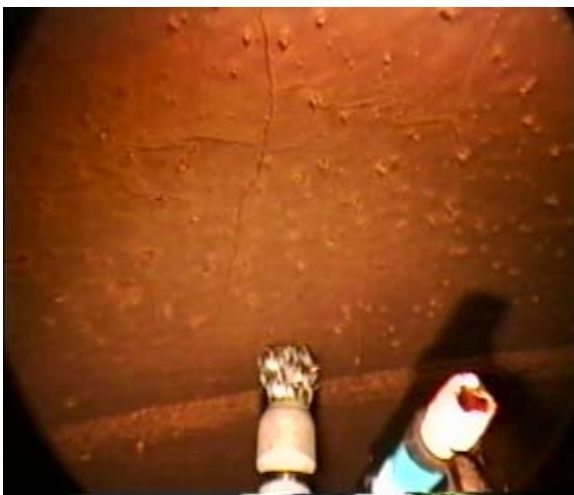
VS #8. Micro blisters in coating. (Time: 26:12)

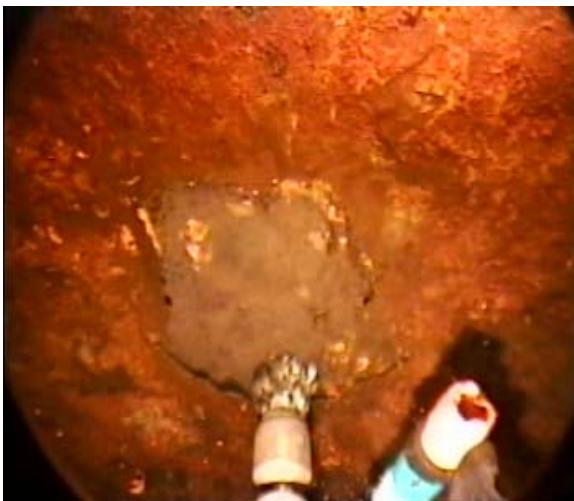
VS #9. Coating failure bare steel – upper section when shell at 9’oclock position. (Time: 33:48)
