Marina Community Partners, Building #2862
Sewer backup on 9/15/11 and History of Backwater Complaints

Attachments: Drawing 9_15_11
 12th Street Old FOR A
 Ord WW Easement Map

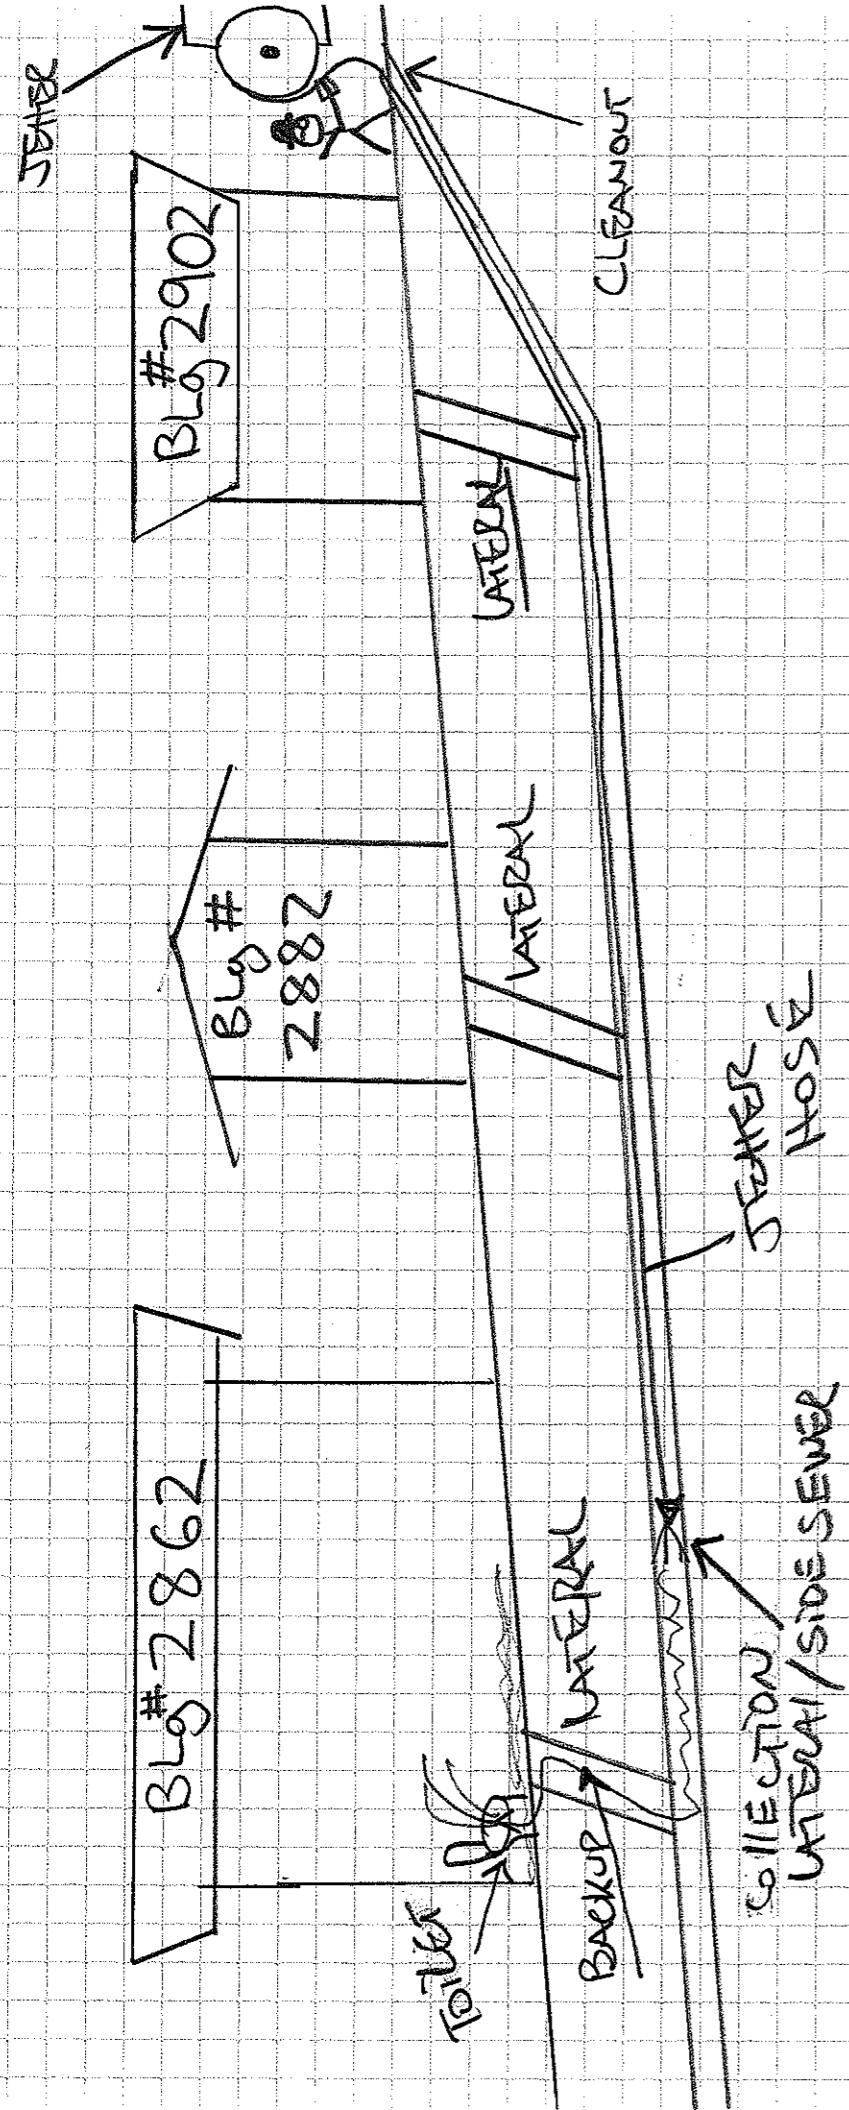
The sewer lines in the vicinity of the Marina Community Partners LLC, Building #2862, located at 100 12th Street, have been maintained by MCWD since 1996 on a corrective maintenance schedule. See attached map for reference location. In previous years, District staff installed four cleanouts at the top of the hill to facilitate corrective maintenance of the side sewers serving the occupied buildings in the 100 12th Street vicinity. Staff has confirmed the subject side sewers were in fact deeded to the District when the Former Fort Ord water and wastewater infrastructure was conveyed to the District in 2001. Please refer to attached Bestor Engineering map of the wastewater collection infrastructure in this area, which has been deeded to the District.

These sewer lines are not properly constructed sewer mains, as they were installed by the Army at the time these barracks were built some 70 years ago. The common wastewater lines that convey flow from multiple buildings in this vicinity are technically “side sewers” by definition, as they do not properly tie into receiving manholes. Most of these lines are directly tied into a sewer main or tied into a manhole in a manner with no access for preventative or corrective maintenance. If sewer mains are to be properly maintained, the utility tasked with maintenance needs proper access to insert a hydro-jetting hose below the blockage. As seen on the attached map, most of these lines do not terminate into a properly constructed manhole or even have a cleanout or manhole at the bottom of the hill prior to the connection to the sewer main.
