Dunes Phase  
1, 2, & 3

# Marina Coast Water District Sewer Master Plan

**SEWER MASTER  
PLAN**

May 2020

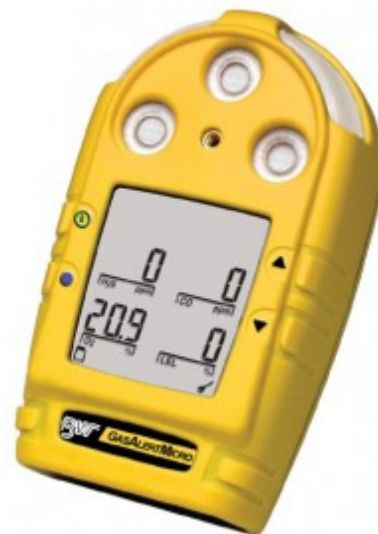
Photo 2-2. Typical Personal Four-Gas Monitor

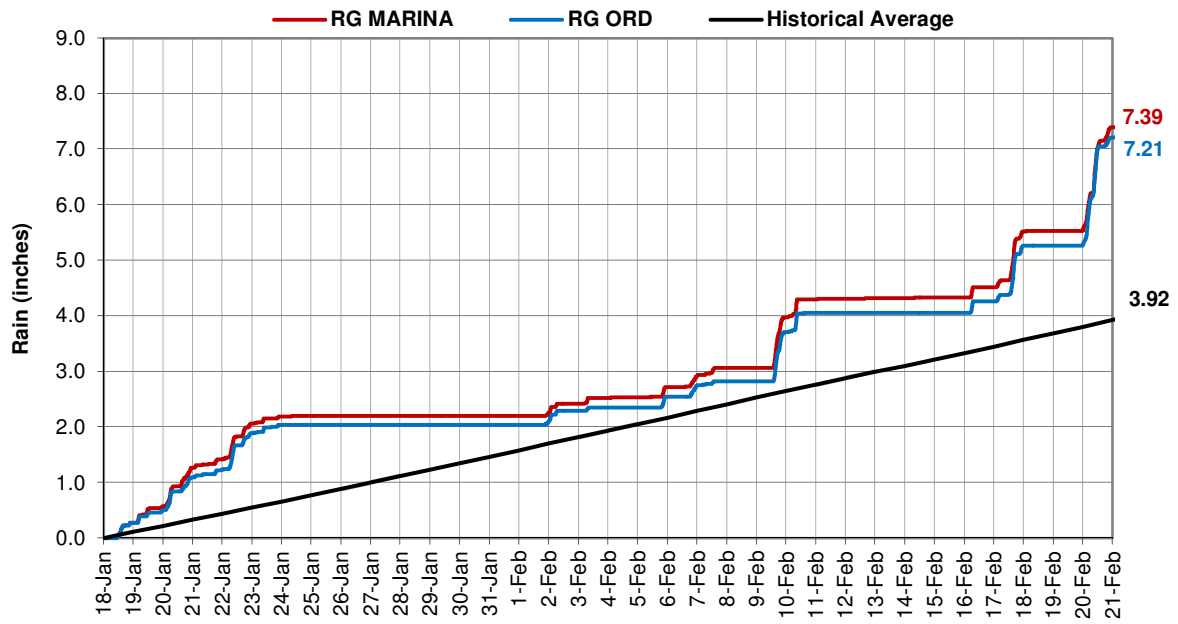
Figure 3-2. Monitored Accumulated Precipitation Compared to Historical Average

There were four main rainfall events that occurred over the flow monitoring period, summarized in Table 3-1. Figure 3-1 shows rainfall activity and intensity over the flow monitoring period (Marina Rain Gauge shown). Figure 3-2 shows the rain accumulation plots for both rain gauges compared to the historical average rainfall<sup>5</sup> in the District during this project duration. Rainfall totals for the District were approximately 86% above historical normal levels during this time period.

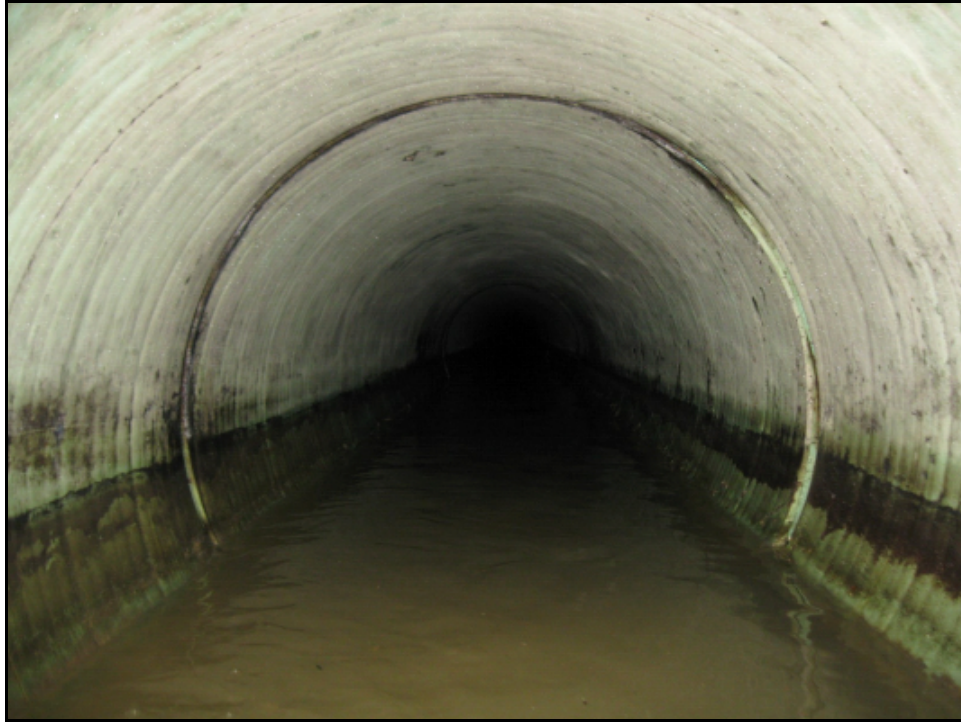
**Effluent Pipe**

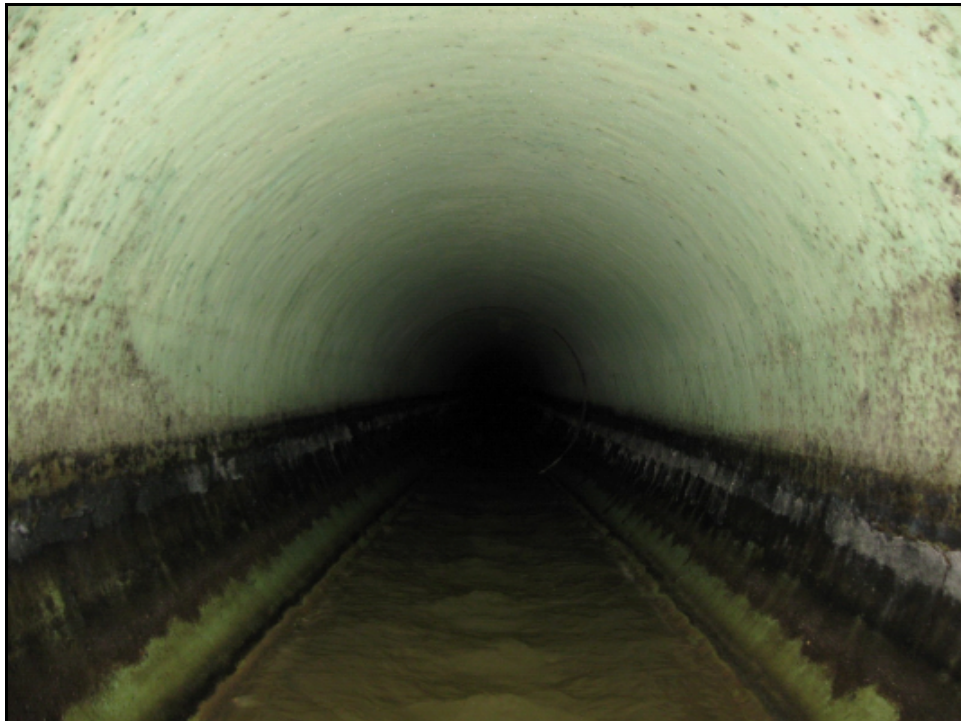
**North Influent Pipe**

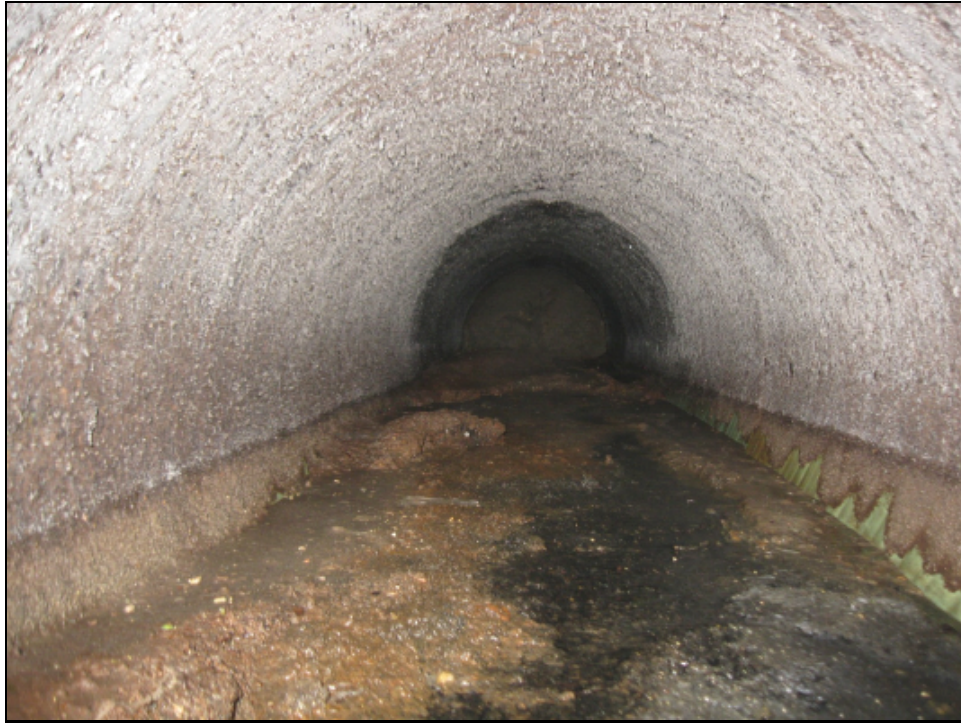
**East Plugged Pipe**

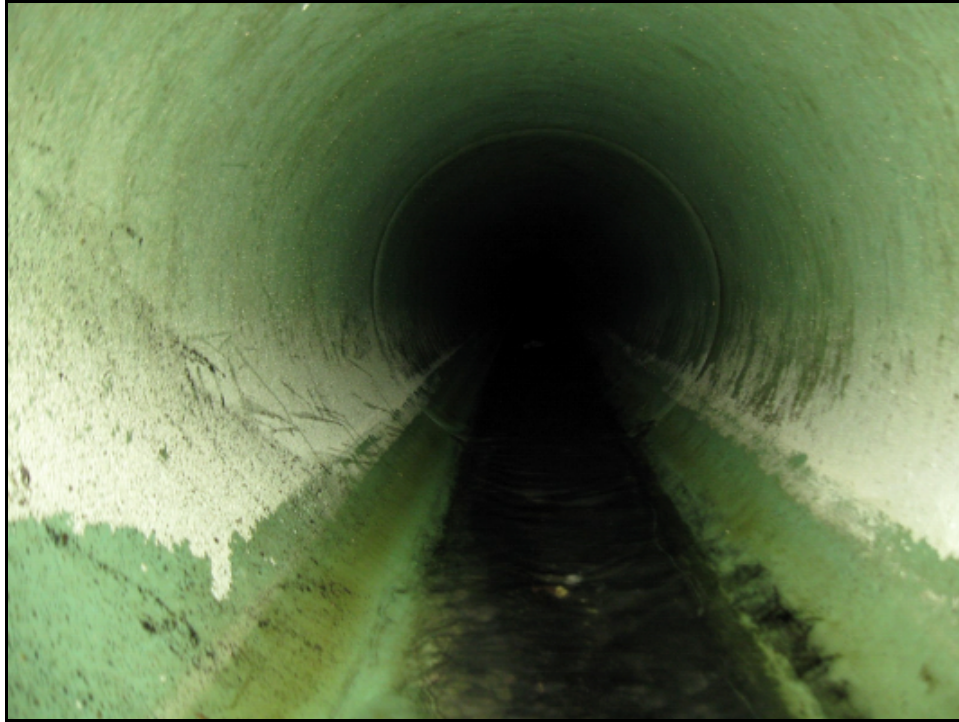
**Effluent Pipe**

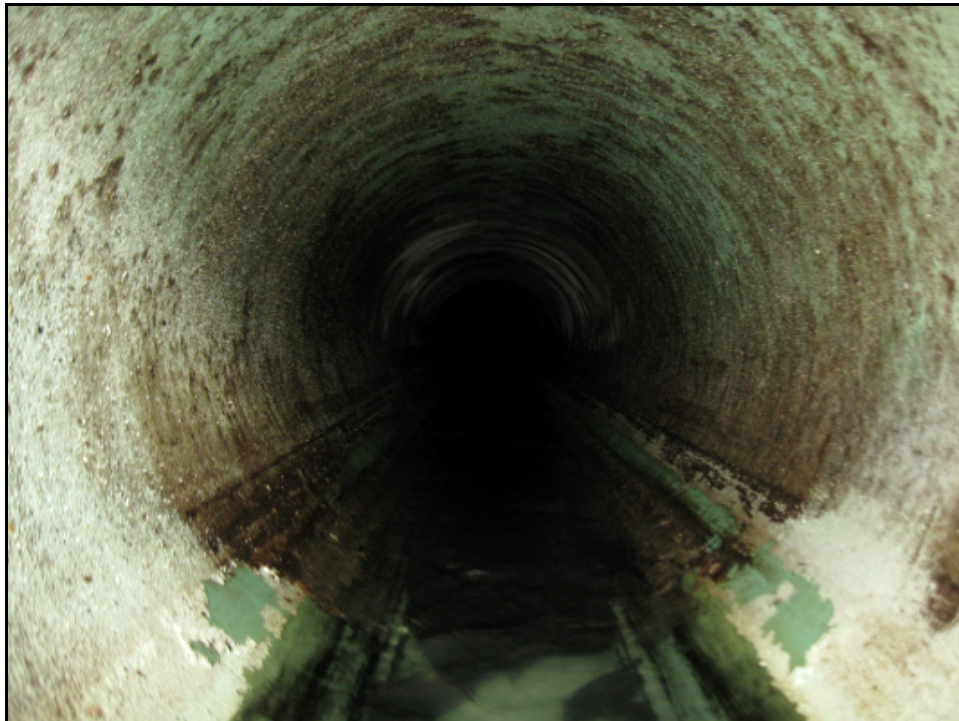
**North Influent Pipe**

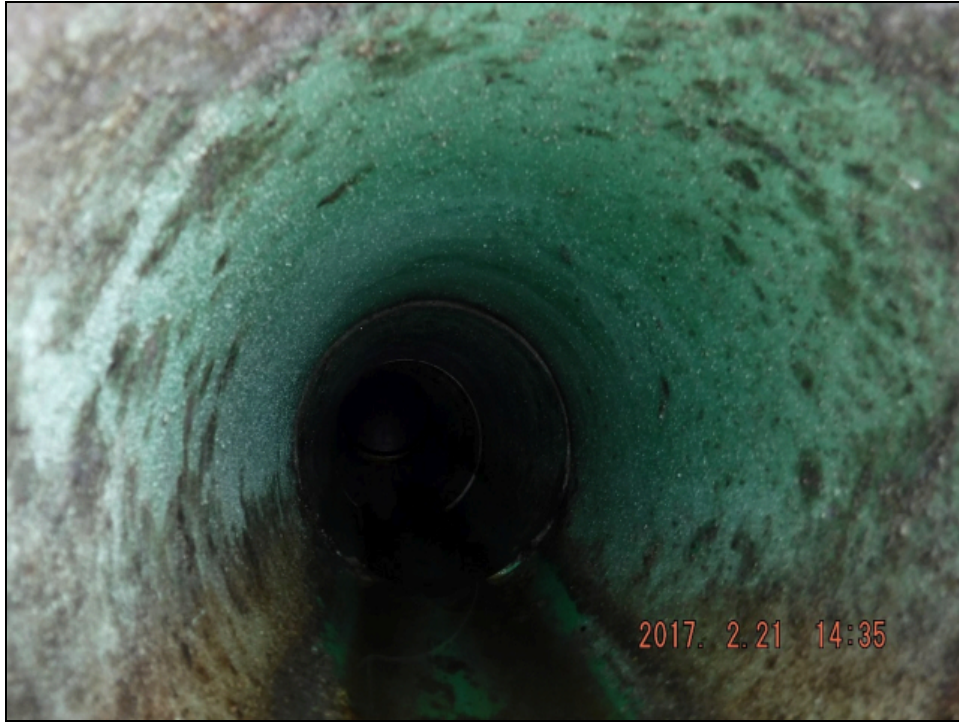
**East Influent Pipe**

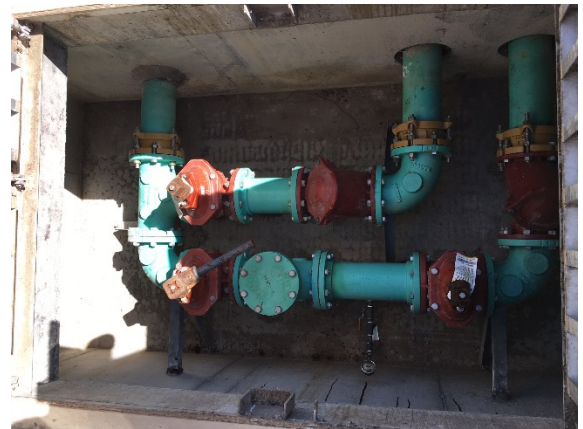
Component
Valve Vault
Score
2
Reason
Valves and piping are in good condition, but valve vault has short clearance to fences.

Within the valve pit, a check valve and gate valve are provided on each discharge pipe. The discharge pipes then combine to form a common 6-inch force main leaving the lift station to the west. The valve pit is located behind the wet well at the rear of the site next to the generator, with very little clearance to the side fences.

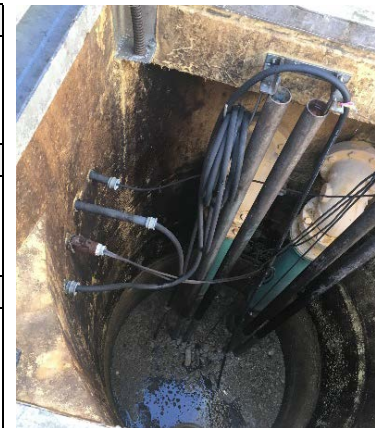
Component
Guide Rails
Score
2
Reason
Minor surface deterioration.

Inside the 6-ft diameter, 13-ft deep concrete wet well, there is surface deterioration visible on the pump guide rails. There is no lifting device on site for pump removal.

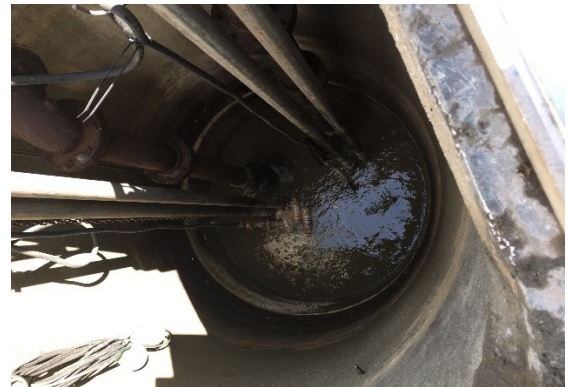
**Wet Well**

Component
Discharge Pipe and Guide Rails
Score
2
Reason
Discharge pipes show signs of corrosion.

The discharge pipes inside the wet well show signs of corrosion, while the pump lifting guide rails appear to be in good condition.

Based on the watermarks at the side of the wet well, the storage in the wet well appears to be adequate.

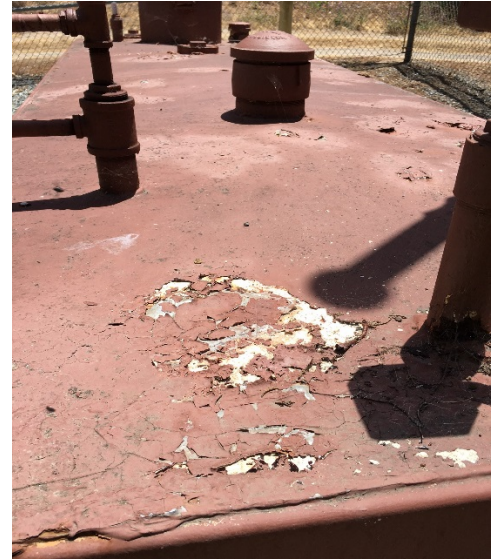
Component
Bulk Tank
Score
3
Reason
Signs of paint deterioration observed.

Signs of paint deterioration were observed on the top of the bulk fuel tank.

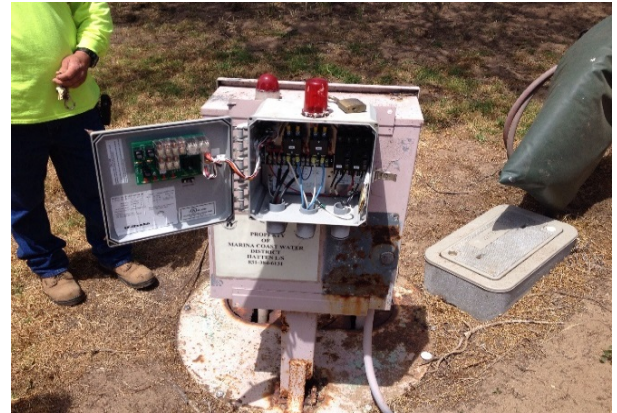
Component
PLC/Telemetry
Score
3
Reason
No PLC/telemetry package. No audible device for alarm notification.

This site is not equipped with the PLC/telemetry package that is present at the other pump stations. The control panel is equipped with two red lights for alarm notification. The presence of an audible device was not noted.

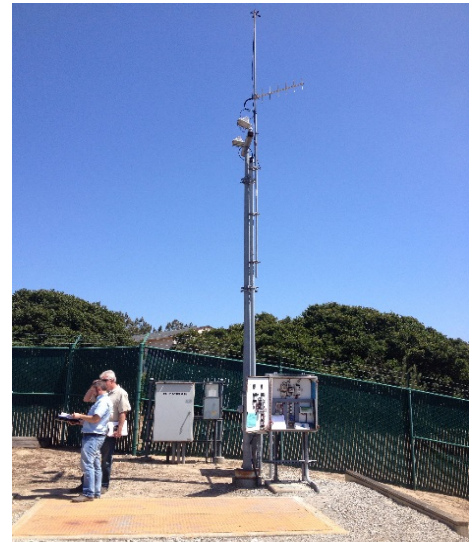
Component
Second Antenna
Score
3
Reason
Unknown purpose from District personnel

A second antenna, appearing similar to a remote cellular antenna, is mounted at the top of the mast. Cabling from this antenna is routed in underground conduit, and could not be traced. The antenna cable was not observed in any of the equipment enclosures. District personnel also were unsure of its purpose.

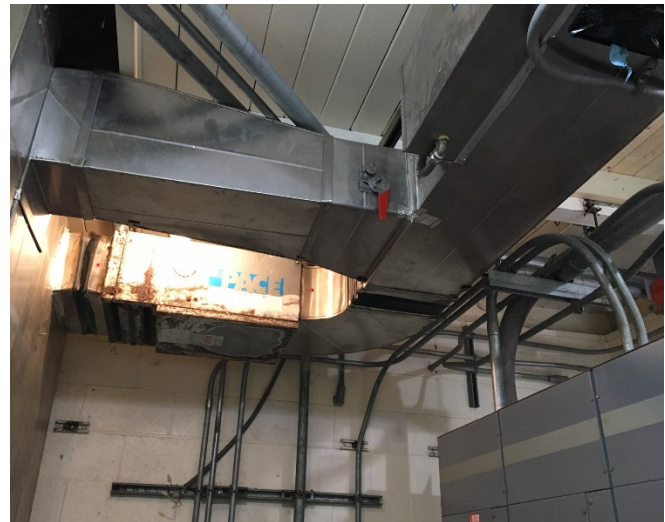
Component
Metal Ducting
Score
3
Reason
Signs of dampness and corrosion. Recommended replacement.

A heating, ventilation, and air conditioning (HVAC) system is also provided to provide ventilation in the below ground areas and to dehumidify the air within the lift station control building (to reduce corrosion and to increase personnel safety). The HVAC system includes a PACE F-1 supply fan, a Baldor 1/3-hp, 530 cfs motor, and a Penn EF-1 exhaust fan with 1/4-hp Marathon motor. Stainless steel ducting draws air from the dry well and

the lift station control room and exhausts the air outside the building. In several locations, especially near the exit wall, the ducting shows signs of dampness and corrosion and is recommended to be replaced.

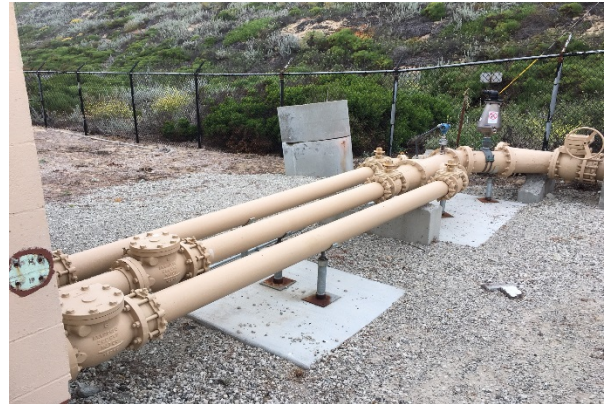
Component
Piping and Valves
Score
1
Reason
New pipes and valves

Piping and valves on the discharge side of the pump station are new.

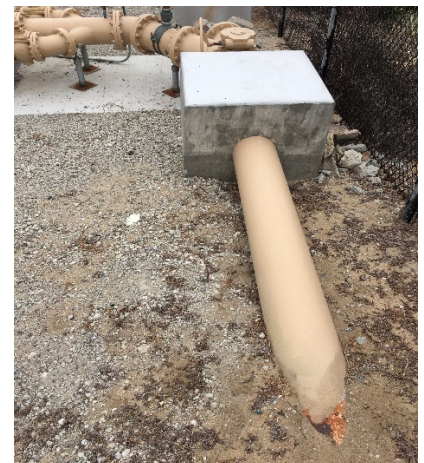
Component
Pipe at end of discharge line
Score
3
Reason
Corrosion – recommended recoat or replacement.

In general, piping and valves appear to be adequate. There does, however, appear to be corrosion at the end of the discharge line, and it is recommended to recoat or replace this section. The extent of exterior corrosion on the pipe is unknown beyond the limits shown in the photo above.

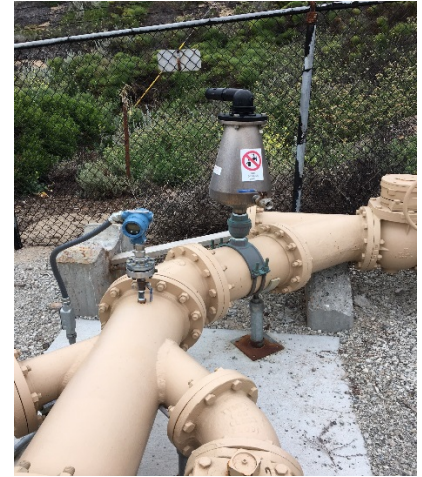
Component
Air Lock issues - Piping / Valves
Score
3
Reason
Force main causing air issues in piping

For this station and for the Gigling Lift Station, even with new pumps installed, there are air lock issues due to problems with the force main. The District reported breaks in the force main. Due to this, the District has been monitoring pressure. There is a lot of bleeding, and sometimes the District will lift up the check valve and backflush before it will prime again. Problems with water hammer have been partially solved by the air release valve. Condition assessment of the force main will require flow handling or bypass. For cost efficiency, condition assessment should be coordinated with other activities at the lift station that necessitate flow handling or bypass.

Due to problems in the force main on the discharge side of the lift station, the operators have a gauge to monitor air pressure. For this station and Fort Ord Village, even with new pumps installed, there are air lock issues. There is a lot of bleeding, and sometimes the District will have to lift up the check valve and backflush before it will prime again. Condition assessment of the force main is recommended to address the air lock issues in the piping at the lift station.

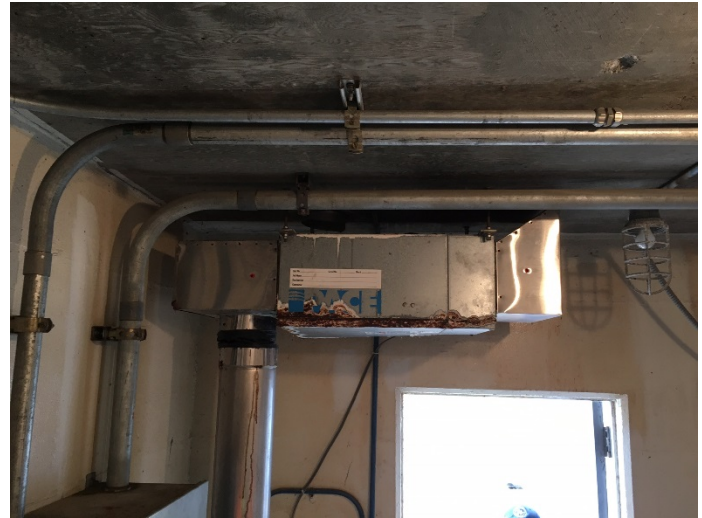
Component
Redesign of HVAC system
Score
5
Reason
Exhaust fan discharges into the building. Strong odor inside the building. Potentially hazardous condition.

The wet well and dry well vents are connected via a single duct to an exhaust fan that is mounted inside the pump station building. The exhaust fan discharges into the building, not outside. This creates a strong odor problem inside the building, essentially negates the attempt to ventilate the dry well, and potentially creates a hazardous condition inside the pump station building. The ventilation system needs to be redesigned to effectively achieve the pump station's ventilation goals.

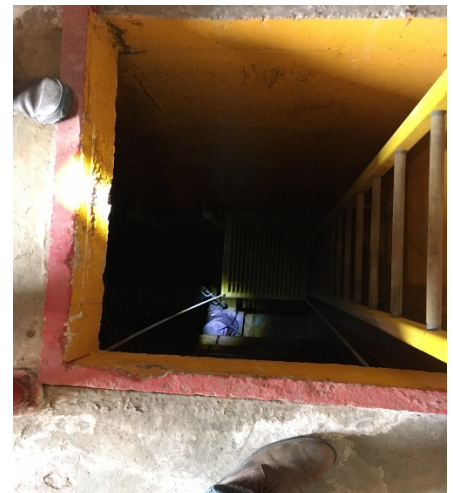
Component	Score	Reason
Dry Pit Dimensions	3	Too deep for valve stems and good access
Component	Score	Reason
Dry Pit Hatch Upgrade	3	Access Hatch too small
Component	Score	Reason
Dry Pit Stairs	3	Stairs preferred over ladder

Both the wet well and the dry pit are deep. If the line in the street is not as deep, it is recommended to build a shallower wet well and dry pit during an upgrade. Access is also limited. It is recommended to widen the access hatch during an upgrade, and construct stairs that lead down to the dry pit.

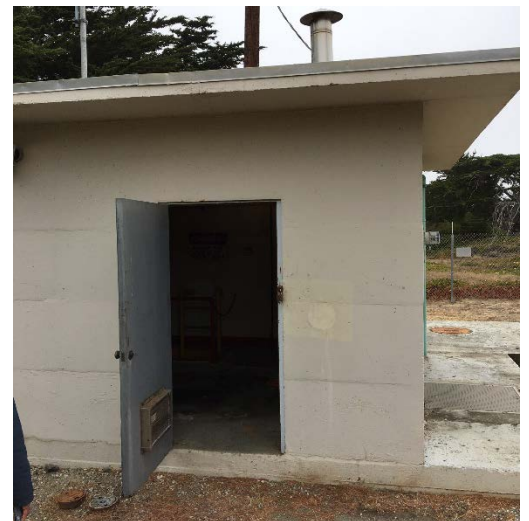
Component
Door
Score
1
Reason
Appears to be in decent condition.

The door appears to be in decent condition. For information on hatches see Wet Well / Dry Pit in Section 4.9.1. There are no windows.

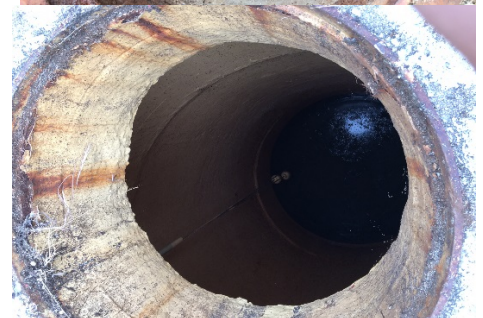
Component
Manhole 1
Score
1
Reason
Walls appear to be in good working condition.
Component
Manhole 2
Score
1
Reason
Walls appear to be in good working condition.

On both sides of the wet well there are manholes. The walls appear to be in good working condition.

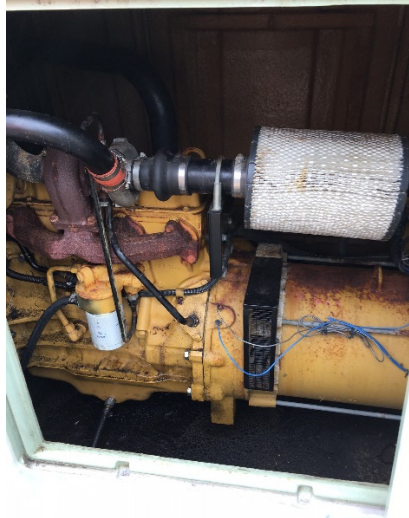
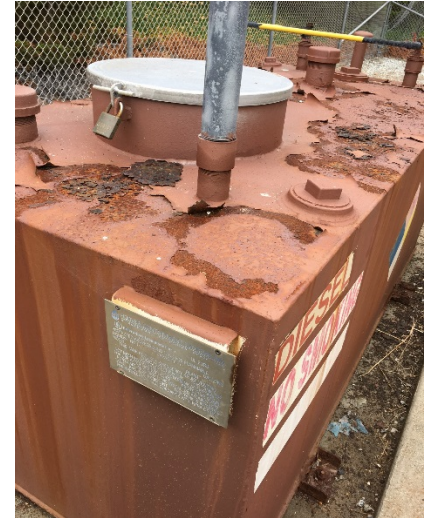
Component
Generator
Score
4
Reason
Reported to have engine valve problems and not in operating condition.
Component
250 gallon bulk diesel fuel tank
Score
4
Reason
Heavily rusted

The generator is reported to have engine valve problems and to not be in operating condition. The 250-gallon bulk diesel fuel tank site is heavily rusted. These elements should be replaced.

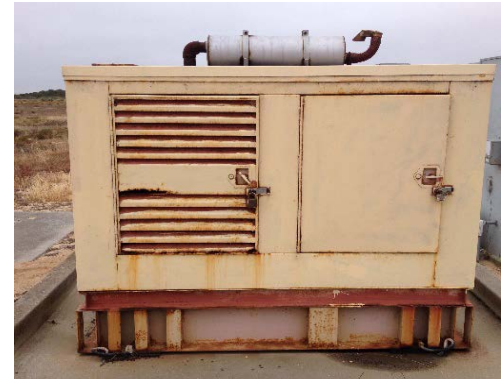
Component
Generator
Score
4
Reason
Enclosure and exposed exhaust system heavily rusted.

The generator enclosure and exposed exhaust system components are heavily rusted. The subbase fuel tank has minor-to-moderate rust. It is recommended for the generator to be replaced.

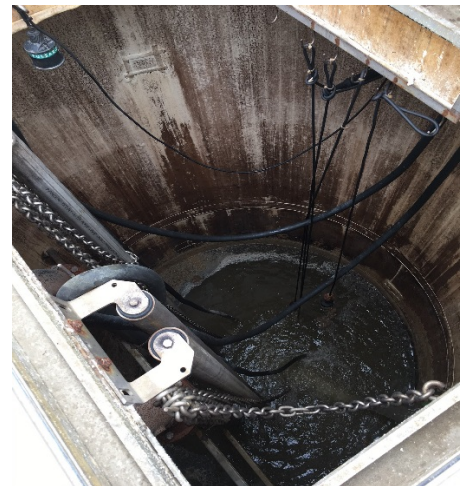
Component
Wet well liner
Score
1
Reason
No issues observed.

The wet well appears to have a liner rather than coating. No issues observed. Wet well dimensions are 8-ft in diameter and 18-ft deep.

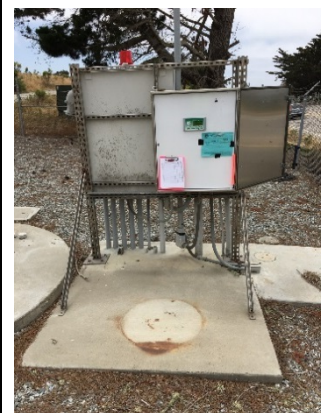
Meter/main panel	1	No issues observed.
Pump control panel	2	Shows minor weathering, otherwise appears to be in good condition.
PVC conduits between the electrical panels and the wet well	3	Appear to be shifting due to subgrade settlement.

The electrical equipment consists of a meter/main panel, and a pump control panel. The pump control panel contains a Zenith Pulsar level controller and combination full-voltage, non-reversing two motor starters. The panels show some minor weathering, but are otherwise appear to be in good condition. The concrete pad on which the electrical panels are mounted appears to be shifting due to subgrade settlement. The PVC conduits between the electrical panels and the wet well may be stressed or broken due to this settlement. It is recommended that the concrete pad and any broken conduits be replaced, and the electrical panels remounted.

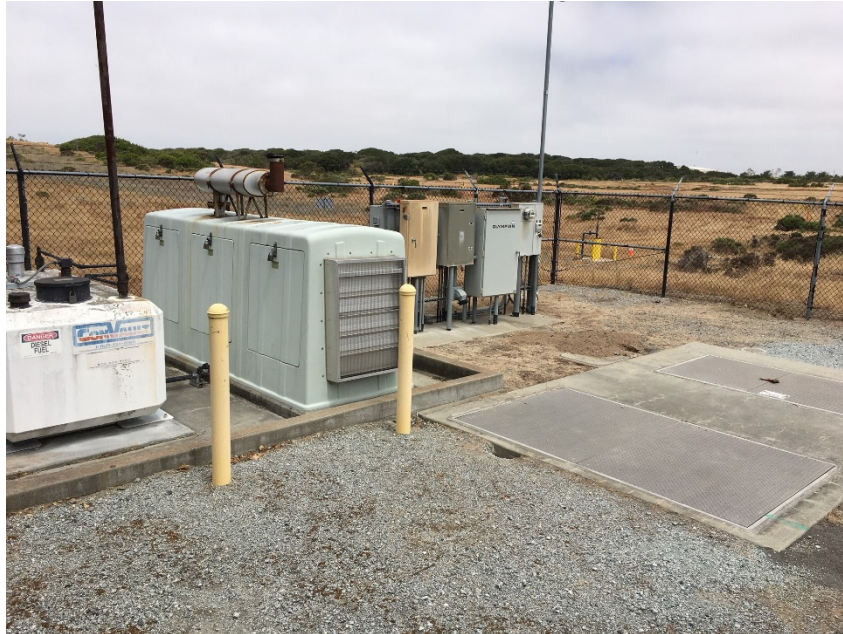
## 4.12 RESERVATION

The Reservation Lift Station is a wet well submersible lift station with no building. Valves and pipes on the discharge side are below grade. Electrical cabinets are above grade. The lift station is fenced in.

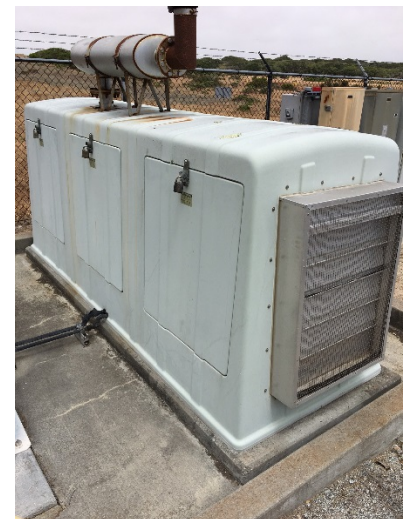
The pump station is equipped with a 100kW Olympian generator, which is mounted inside a weather-protective fiberglass enclosure.

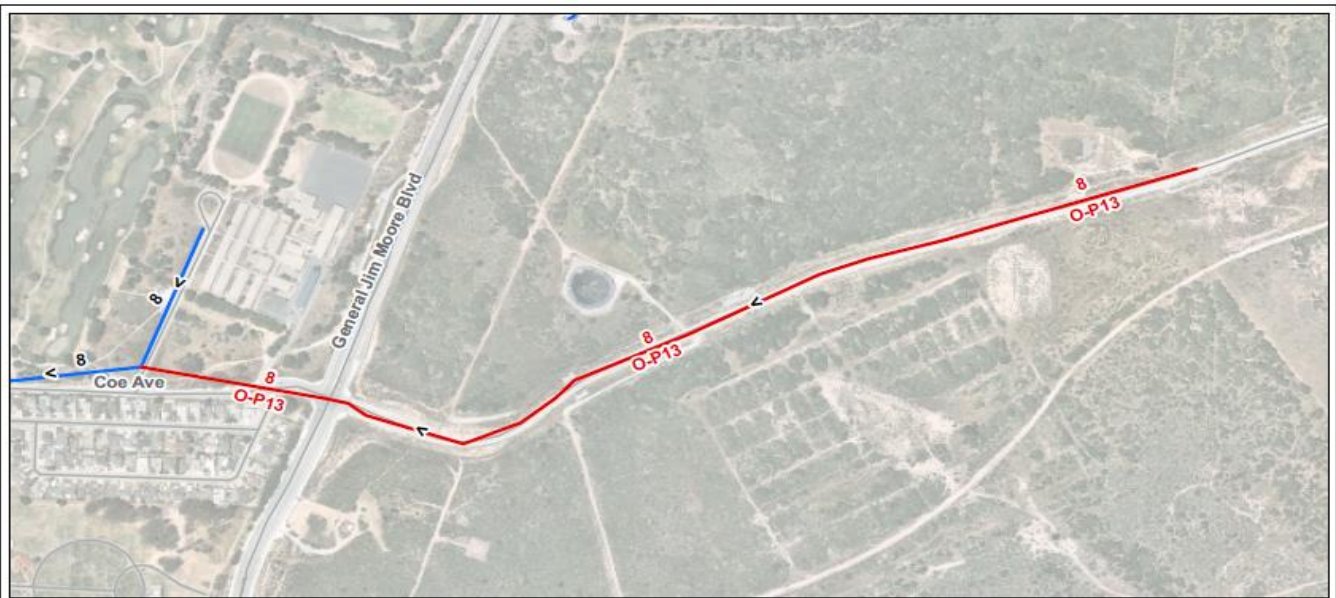
This project includes the construction of a new 8-inch gravity main along Eucalyptus Road from approximately 4,000' east of General Jim Moore Boulevard to approximately 800' west of General Jim Moore Boulevard. This project is planned to serve potential development along Eucalyptus Road.
