FINAL GEOTECHNICAL REPORT

Marina Coast Water District Regional Urban Water Augmentation Project – Distribution Mains Monterey County, California

**Subject: Marina Coast Water District
Regional Urban Water Augmentation Project – Distribution Mains
Monterey County, California**

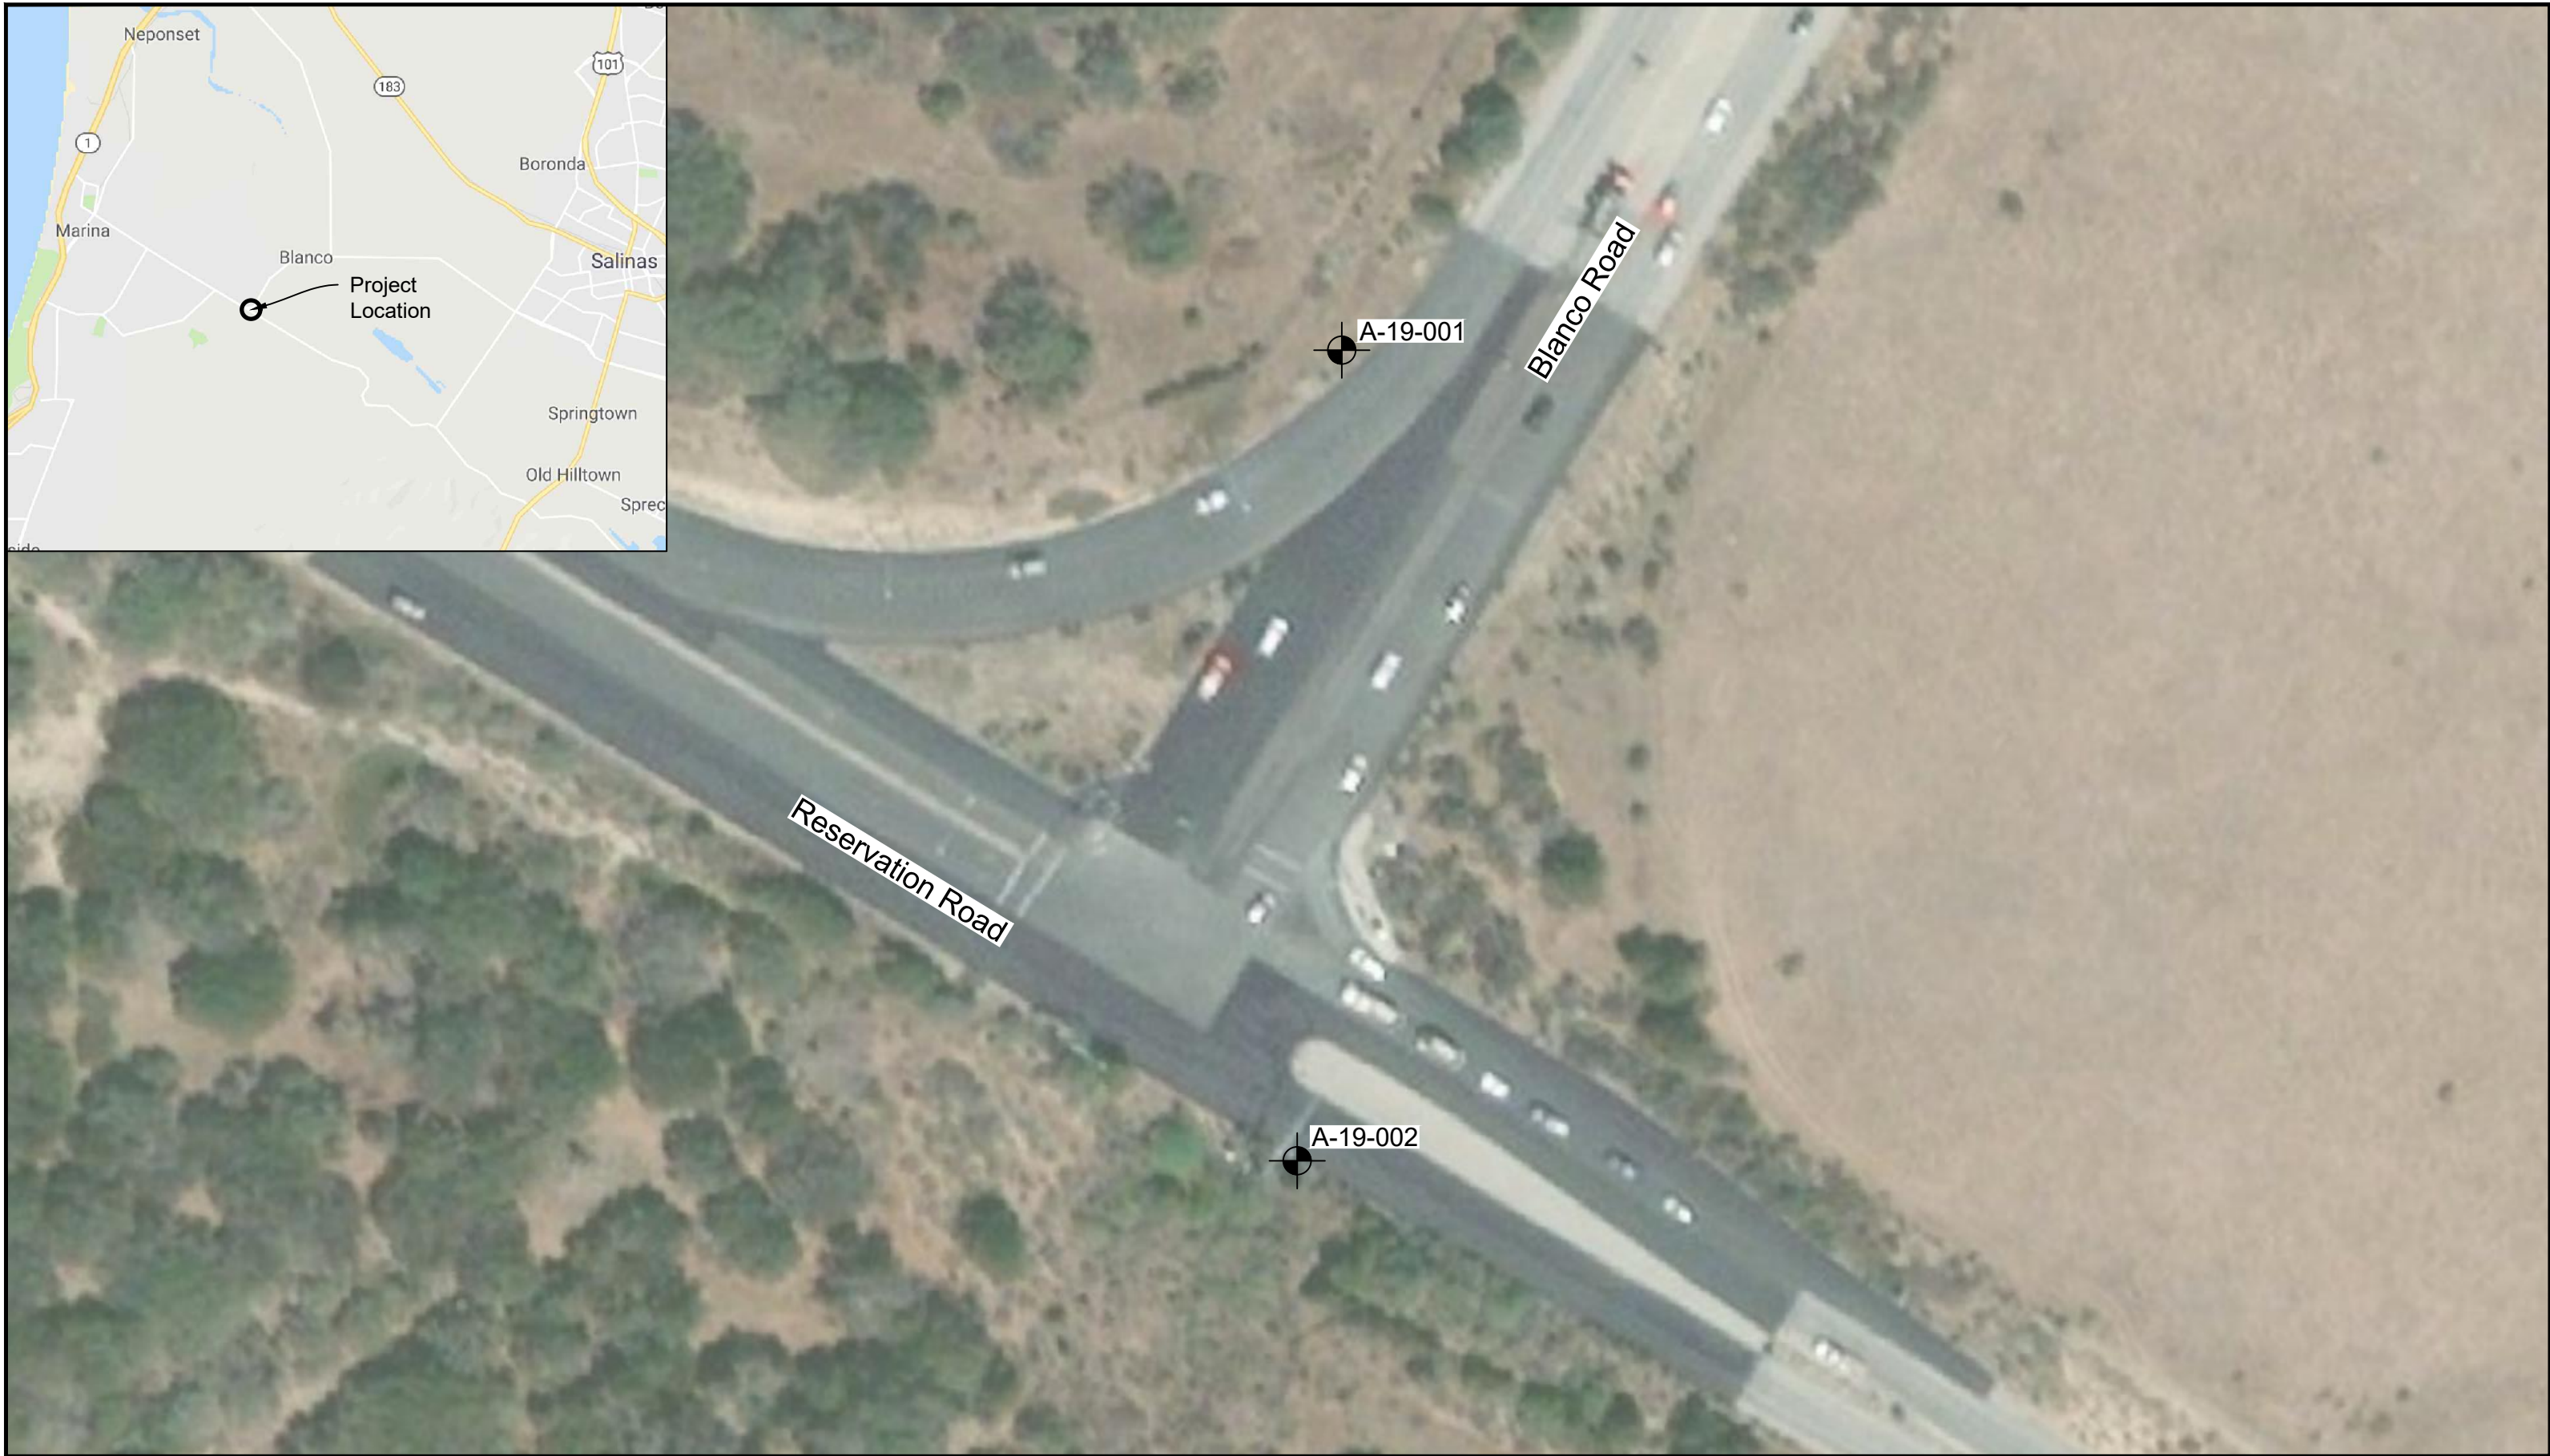
Figure 1
 Exploration Location
 Map
 Proj. No: 19-513.1
 Scale: 1"=70'
 Date: 4/9/19

A-19-001 BORING LOCATIONS

The project site is in Marina, Monterey County, California. The site coordinates are approximately latitude 36.666935° N and longitude 121.756757° W. See the Figure 1 for the site vicinity map.

The test borings were logged consistent with the Unified Soil Classification System (USCS) and the Caltrans 2010 Logging Manual. Selected portions of recovered drive samples were retained in sealed containers for laboratory testing and reference. Additionally, bulk soil samples were retained in sealed bags for laboratory testing and reference. No groundwater was observed during drilling operations. At completion, test borings were backfilled with cement grout and native soil. The locations of test borings are shown on Figure 1.

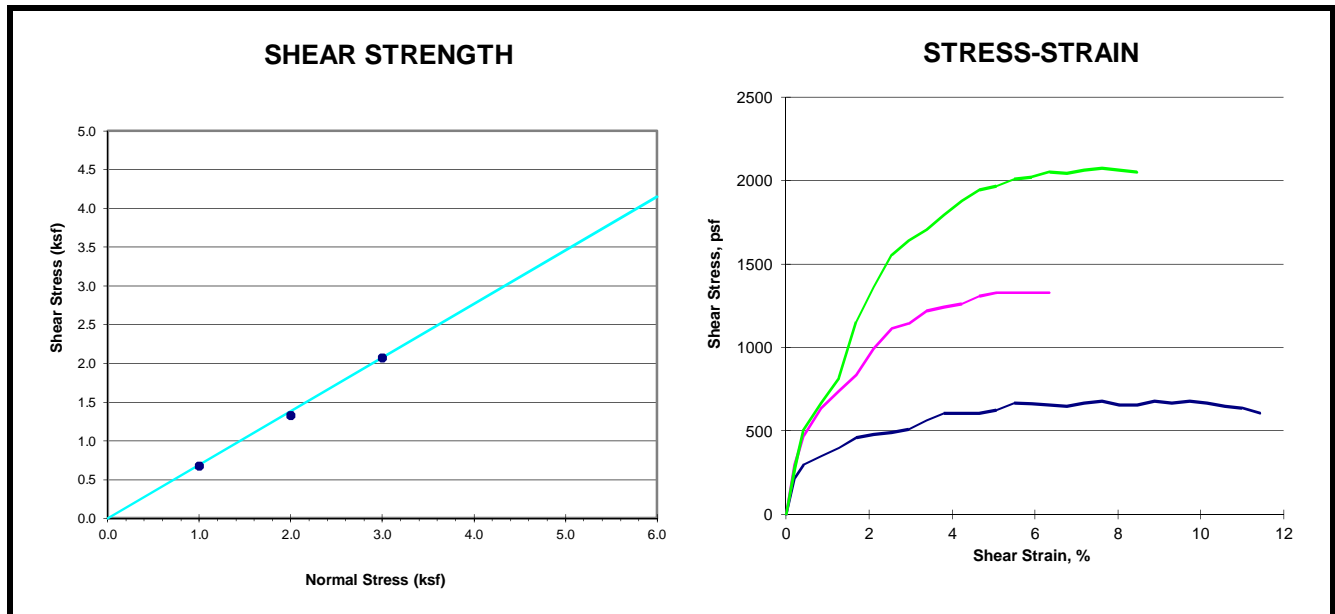
Boring Number	A-19-001-4A
Sample Depth (feet)	
Material Description	Yellowish Brown Silty SAND

Sample ID (psf)	1000	2000	3000
Height (inch)	1.00	1.00	1.00
Diameter (inch)	2.363	2.363	2.363
Moisture Content (%)	12.0	10.9	9.5
Dry Density (pcf)	101.4	105.1	99.9
Estimated Specific Gravity	2.85	2.70	2.70
Saturation (%)	45.2	48.8	37.3

Strain Rate (%/min)	0.293	0.289	0.313
Major Principle Stress at Failure (psf)	677	1326	2074
Strain at Failure (%)	8.89	5.08	7.62

ϕ , degrees	34.7
c, psf	0

Direct Shear
 Cohesion = 0 psf
 Friction Angle = 34.7 degrees
